Comparison of Spacecraft Contamination Models with Well-Defined Flight Experiment

NAS8-40581

Progress Report for May 15, 1997 to August 15, 1997

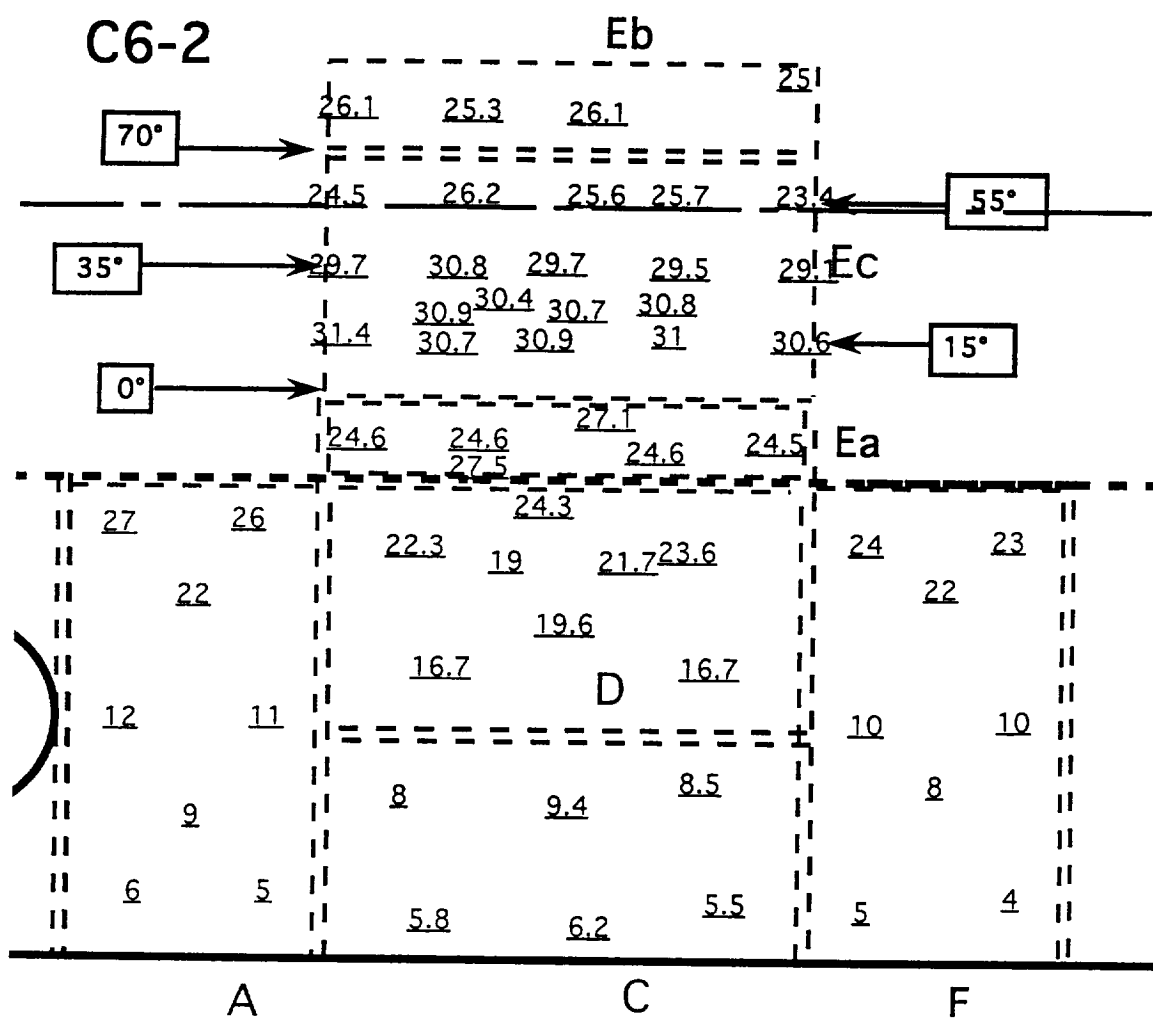
Figure 1.

Diagram showing Percent Silicon on the tray surface C6-2 at the measured locations for all individual ESCA measurements.

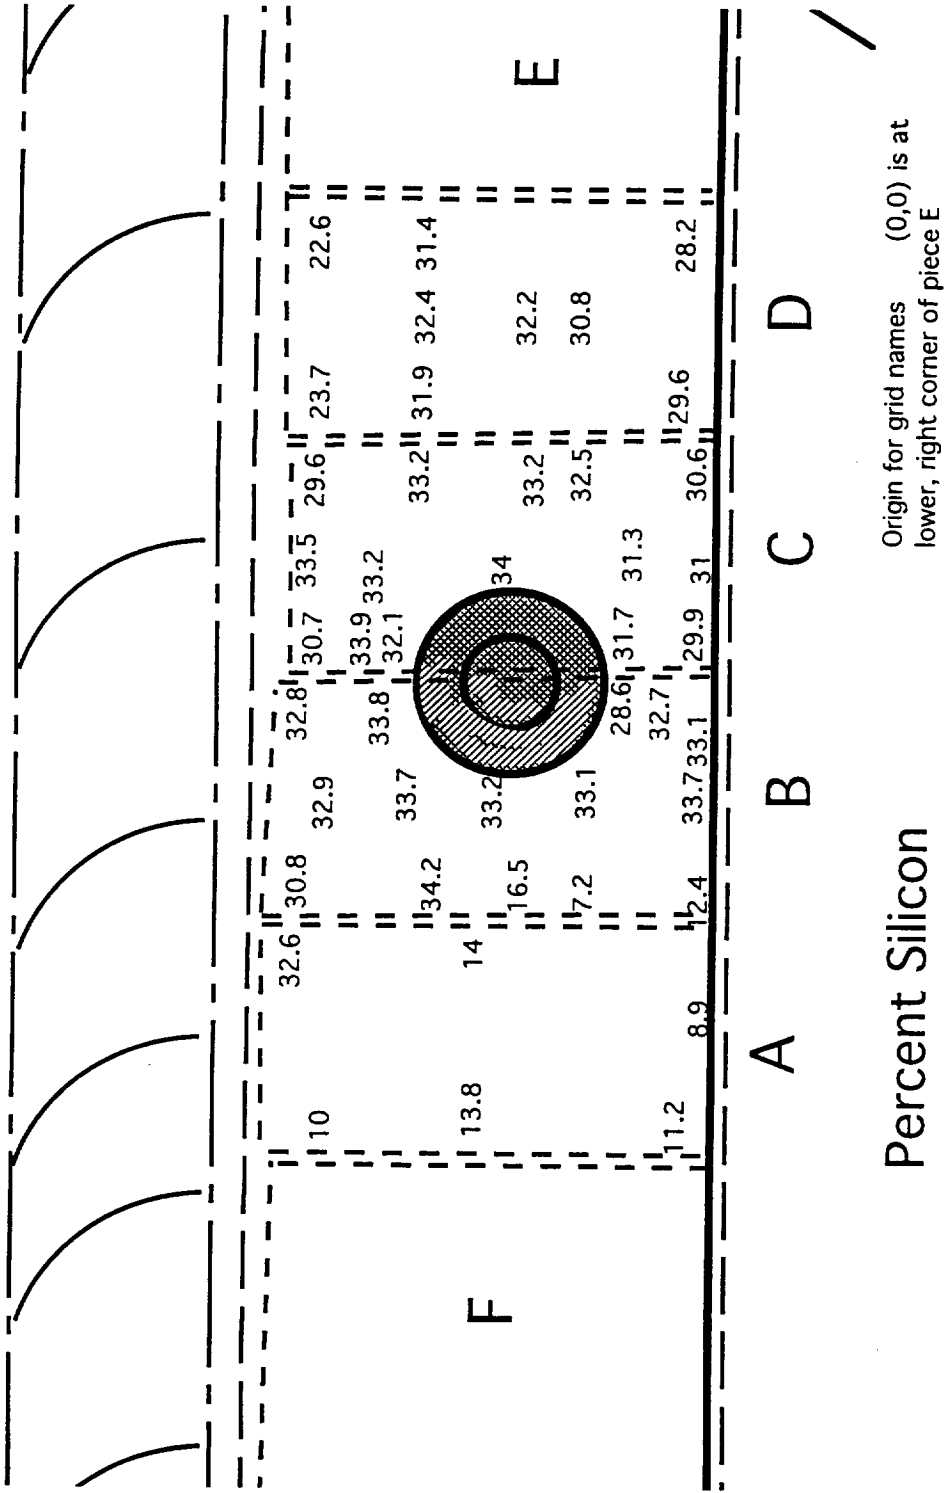
Figure 2. Diagram showing Percent Silicon on the tray surface E10-8 at the measured locations for all individual ESCA measurements.

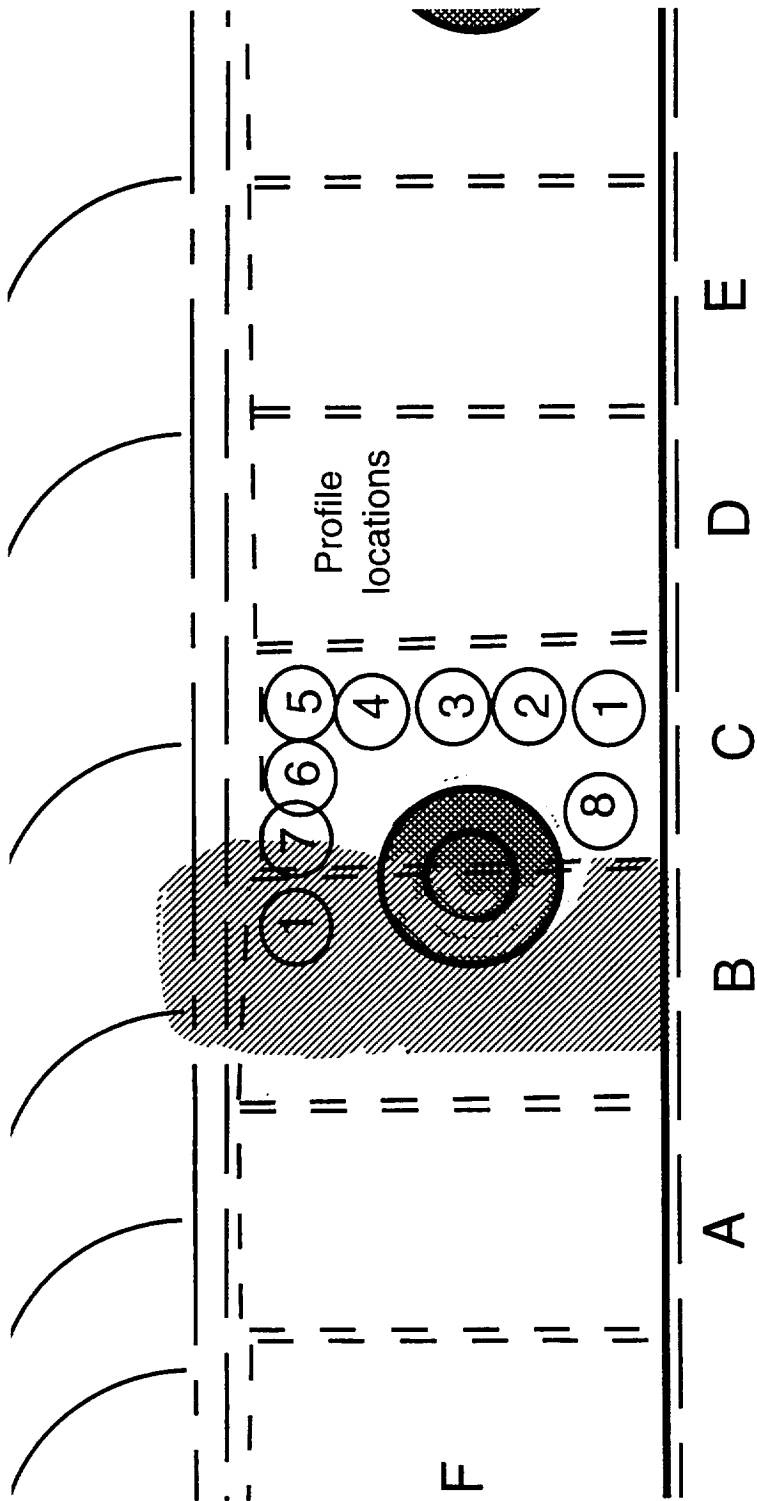
Figure 4. Locations of auger depth profiles obtained to-date from tray location E10-8.

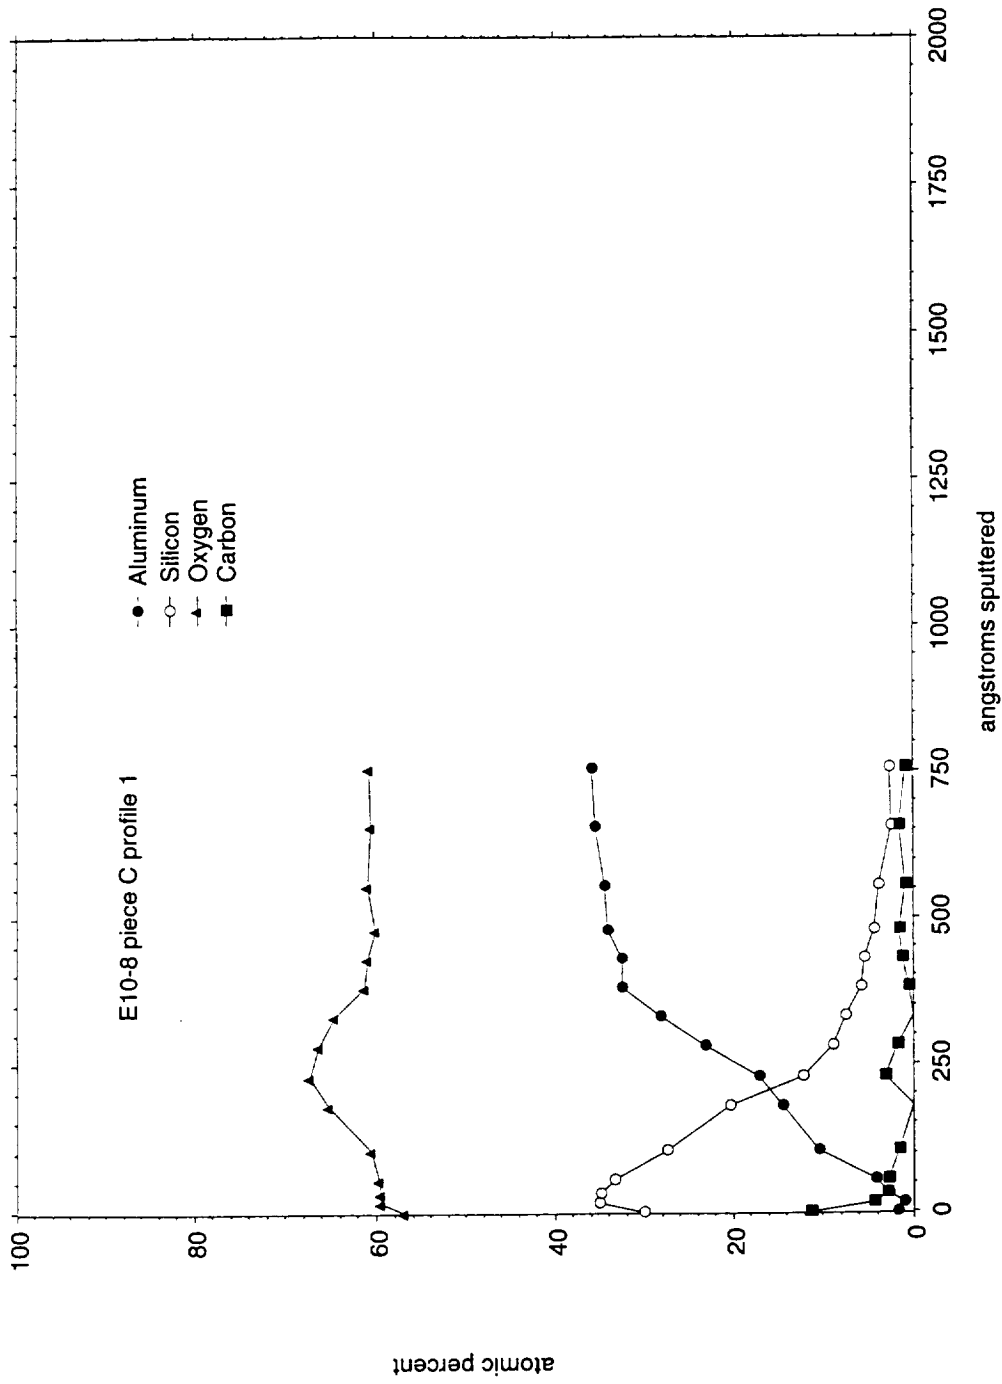
To begin to interpret these profiles it should be kept in mind that the mission time essentially goes from right to left. The first material deposited is the material with the very high carbon content. The periodicity in the intensity levels may be a function of seasonal variation of the sun orientation with respect to the surface, but this is just a guess at present. The oxygen flux rate was much greater toward the end of the LDEF flight relative to the first 3-4 years, so much of the surface oxidation could have occurred over the last few months of the flight. In summary, the contamination deposits directly across from the vents are complex mixtures of materials and the mechanisms by which they may have been changed, once deposited on the surface, are not yet clear. The next surface to be depth profiled will be from tray C6, which saw less than 1% of the atomic oxygen exposure received by tray E10. Tray C6 did see about 60% of the solar exposure level received by tray E10.

Figure 5. Depth Profile showing Silicon, Carbon, Aluminum, and Oxygen elemental %'s at location "C-1" from tray surface E10-8.

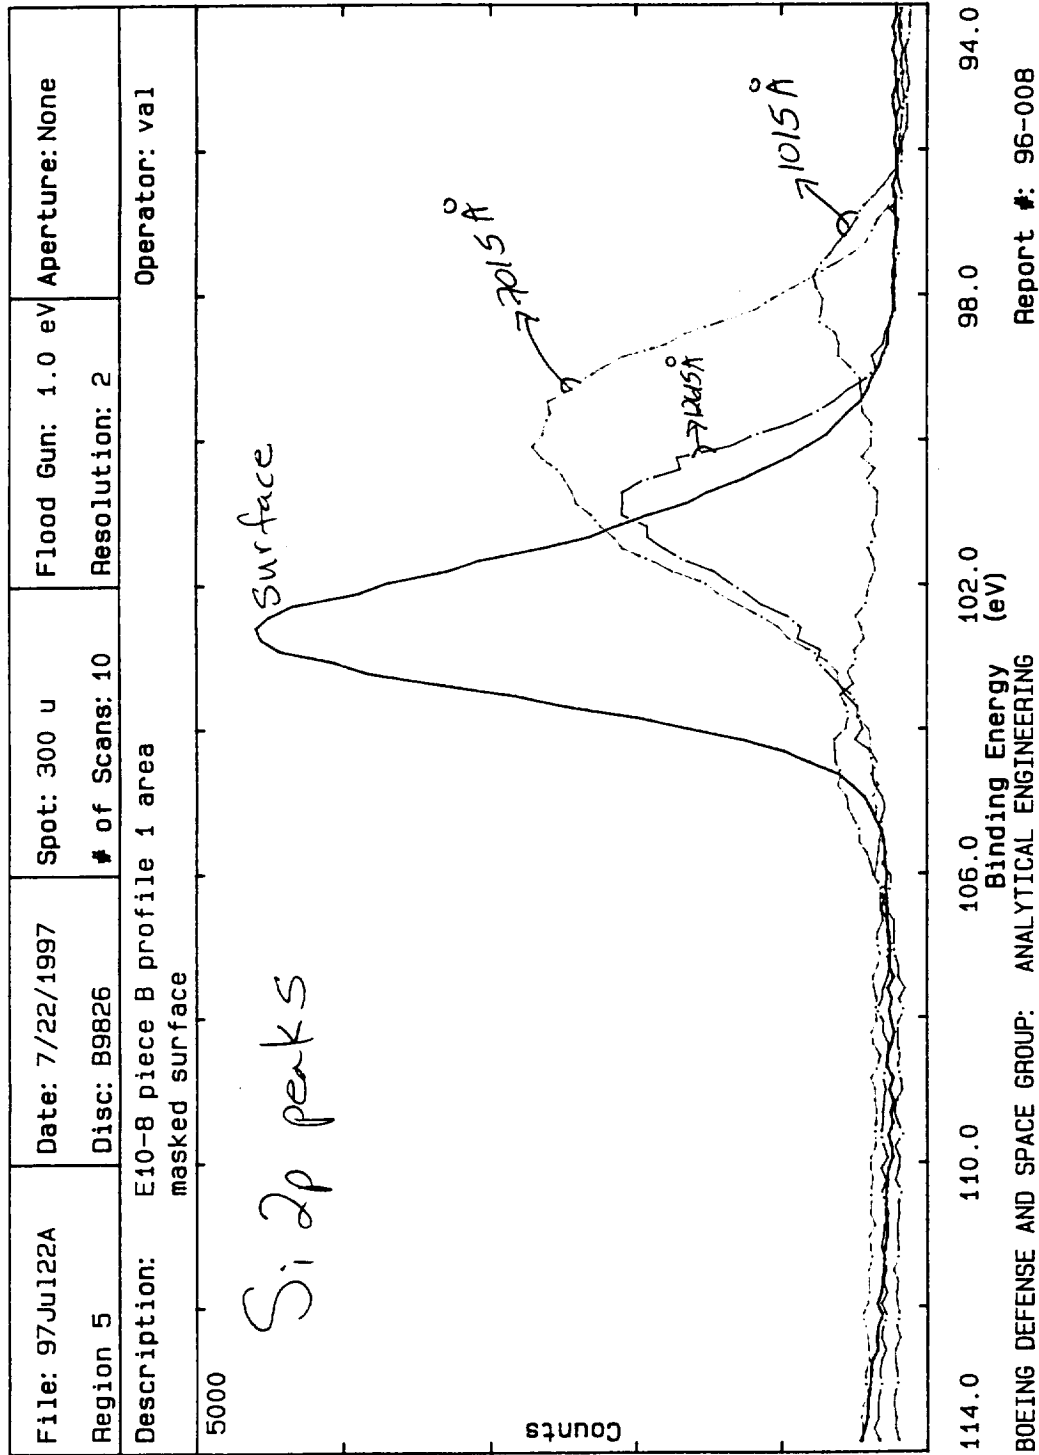
Figures 14 and 15 show peak energies and peak shapes for silicon ESCA peaks at different sputtering depths. The peak positions have not yet been corrected for possible charging effects. The position of the Carbon peak has also been measured at each of the nominal depths, but this data is not yet available. The areas under the peaks reflect the relative amounts of silicon at the different depths. Figure 15 shows the peaks normalized to identical areas in order to show the relative shapes of the peaks. The peaks at a nominal depth of 101.5 nm suggest at least two very different materials mixed at this level.

Figure 14. Silicon 2p peaks at selected sputtering depths, showing relative peak areas.

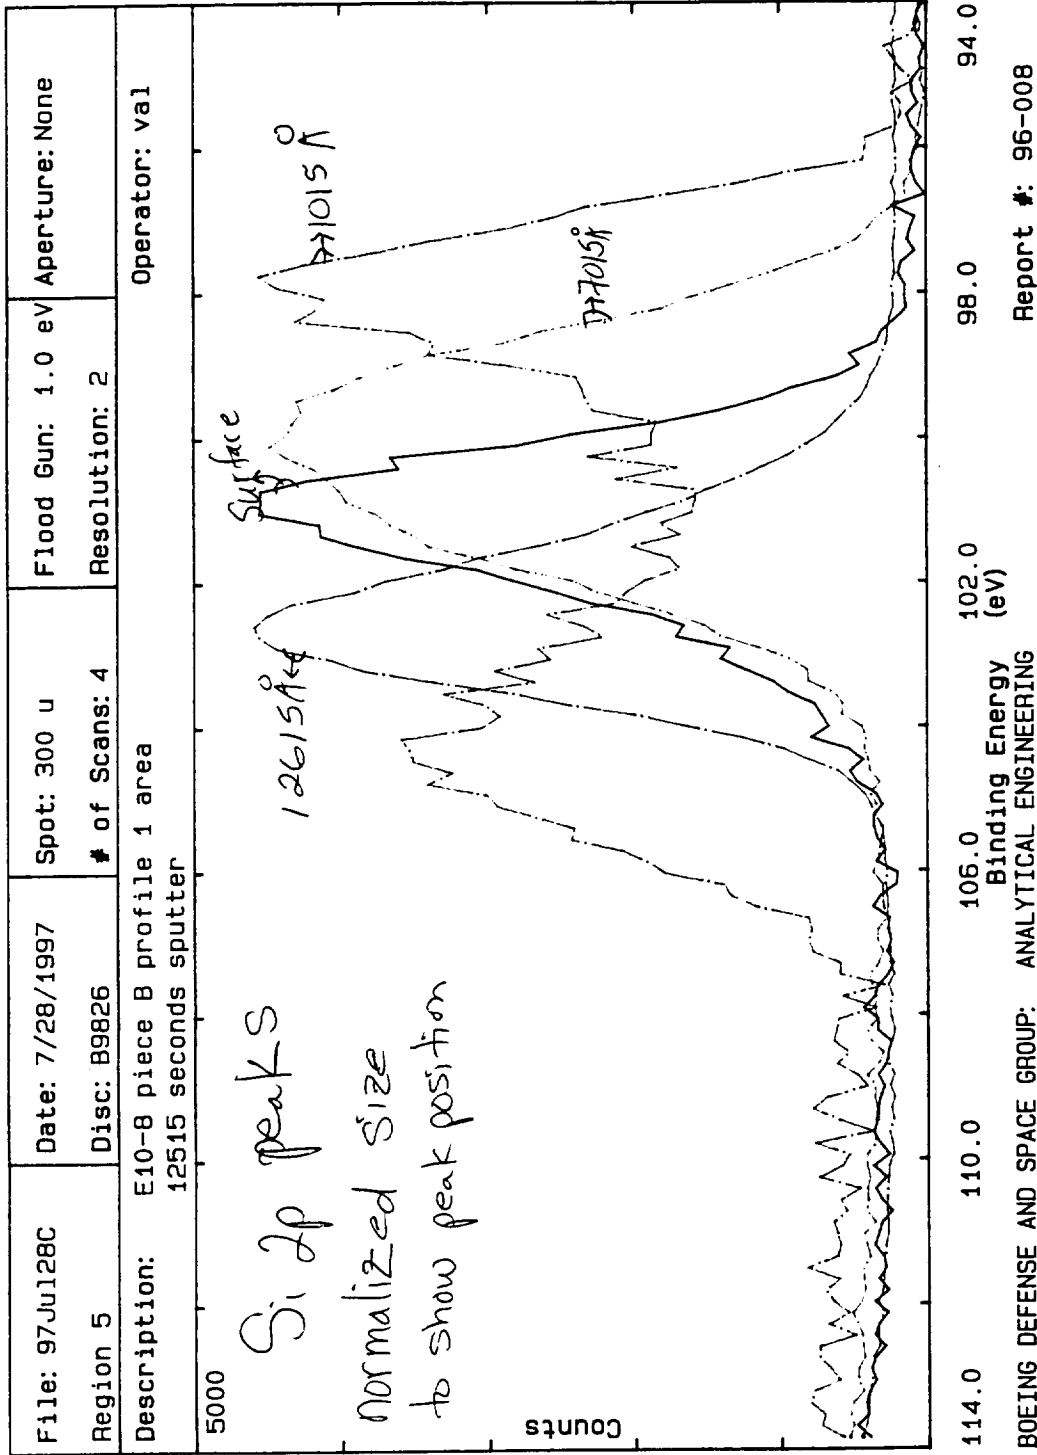
Figure 15. Silicon 2p peaks from figure 14, with areas normalized, to show peak shapes more clearly.
